# EXPLOSION AT WALTON COLLIERY YORKSHIRE

On the causes of, and circumstances  
attending, the explosion which occurred at  
Walton Colliery, Yorkshire,  
on 22nd April, 1959

**T. A. ROGERS, C.B.E.**

**H.M. Chief Inspector of Mines and Quarries**

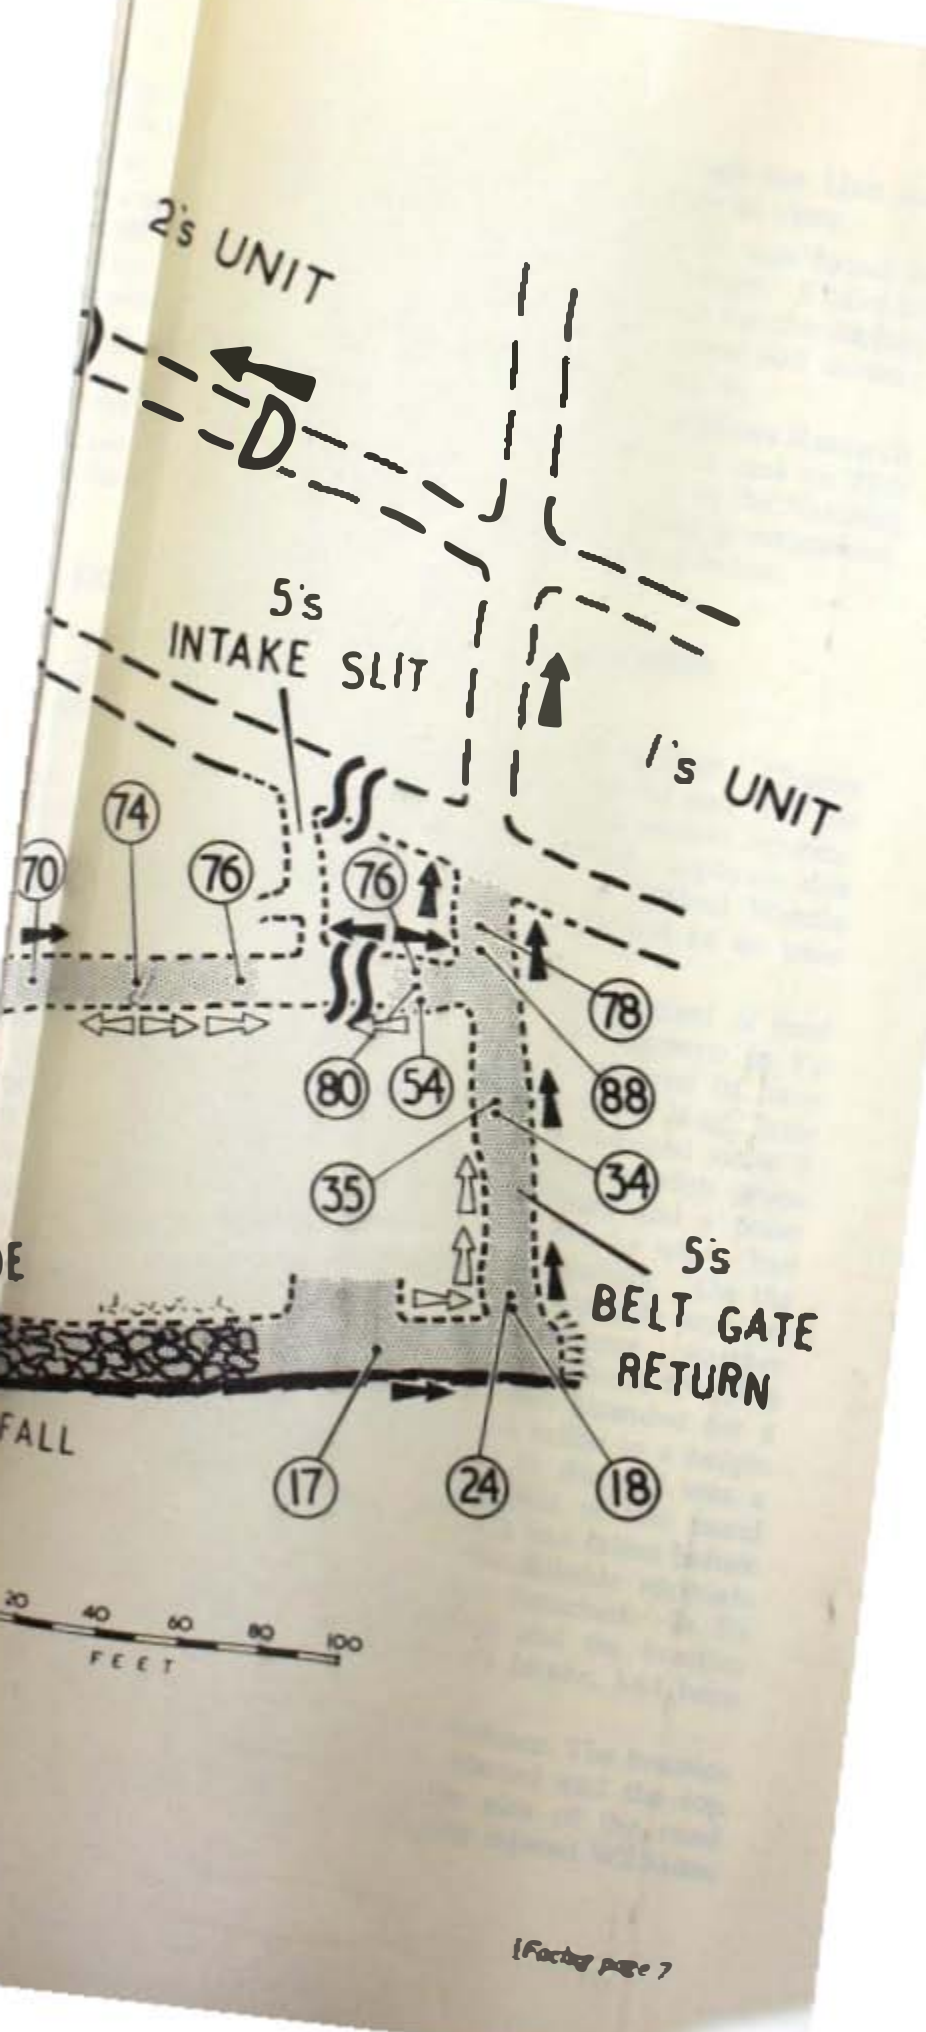
FIGURE 1

28. There were no indications of great violence in 5's Unit. Charles Ray, whose body was found at 5's Return Gate ripping lip and was the one farthest from 5's face, was the only one who suffered violent injuries. The other four men died from carbon monoxide poisoning ; asphyxia due to the inhalation of coal dust accelerated the deaths of Wilfred Wardle and Lawrence Coe. All the dead men sustained burns, but in no case would these alone have been fatal.

29. Physical damage was confined mainly to the displacement of roof supports and to the disturbance of conveyor belts. The supports in 5's Intake were undisturbed (except for two props which appeared to have been blown out from under the ripping lip) and a flame safety lamp, later identified as that issued to Coe, was found hanging undamaged some 5 yards from the ripping lip. Face supports (consisting of wooden props and bars) had been displaced between the Intake roadhead and a point about 10 yards from the Ribside, but apart from some chocks which had partially collapsed the waste edge supports were still standing. On the 10 yards of the face nearest the Ribside, and for 25 yards along it, supports had not been disturbed and there was little sign of violence. Farther outbye on the Ribside, supports had been dislodged and about 55 yards from the face there had been a heavy fall of roof which extended for a distance of 37 yards ; it was estimated that the roof had fallen to a height of about  $3\frac{1}{2}$  feet above the seam. The bottom layer of this fall was a panel of sandstone some 9 to 12 inches thick. The ends of this panel were covered with explosion dust and it was clear that it had fallen before that dust had settled. Outbye of this fall most of the Ribside supports had been dislodged and the conveyor head had been disturbed. In 5's Return the top belt of the conveyor had been broken and the brattice sheets in the new connection between 5's Return and 5's Intake, had been blown down.

Plan showing development of the explosion
